Navajo Abandoned Uranium Mine

Site Screen Report

Upper Canyon AUM Site

March 2010

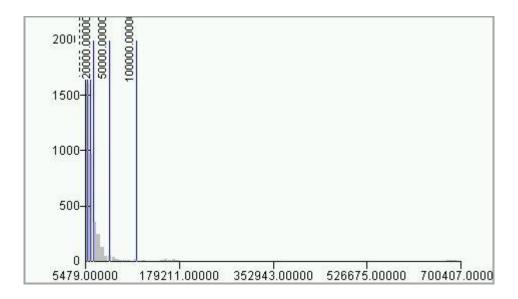
Distribution Chart and Statistics:

The following chart and statistics were generated by ESRI ArcGIS 9.3.1, and show the general distribution of the site gamma radiation measurements. The horizontal X axis represents the gamma radiation reading levels in cpm (lowest levels to the left). The vertical Y axis represents the frequency of each gamma radiation level.

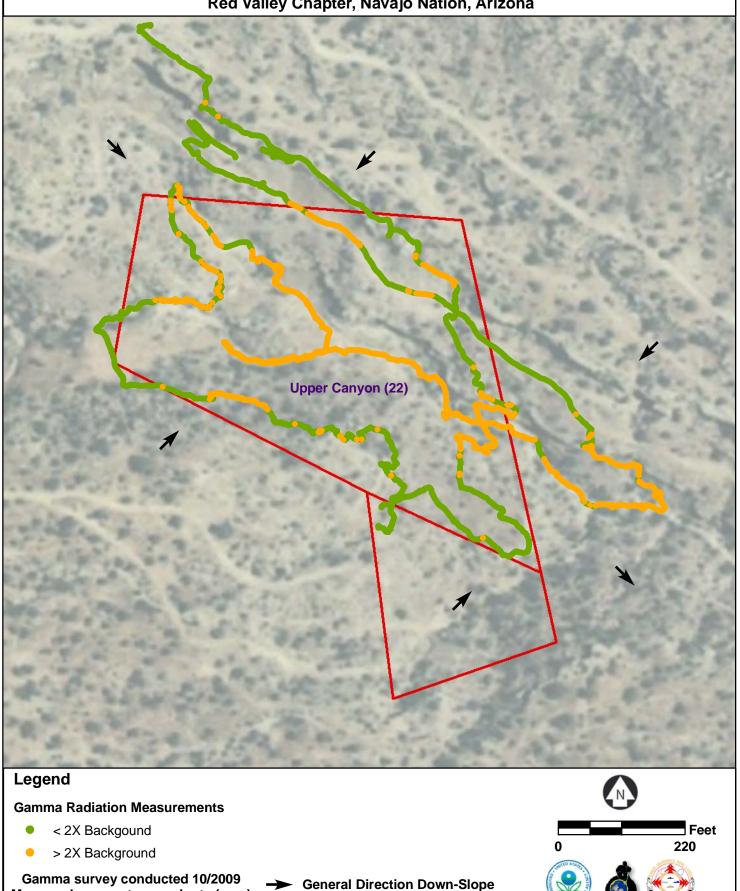
Figure 1 - Gamma Radiation Measurements, Above Two Times Background **Upper Canyon (22)** Red Valley Chapter, Navajo Nation, Arizona

A total of 3,607 gamma radiation measurements were collected from the mine site, ranging from 5,479 cpm to 700,407 cpm. The measurements are represented in Figures 1 and 2.
